Carrollton-Farmers Branch ISD **cfb BOND** **DOLLARS AT WORK**

BLANTON ELEMENTARY SCHOOL

FCI Update

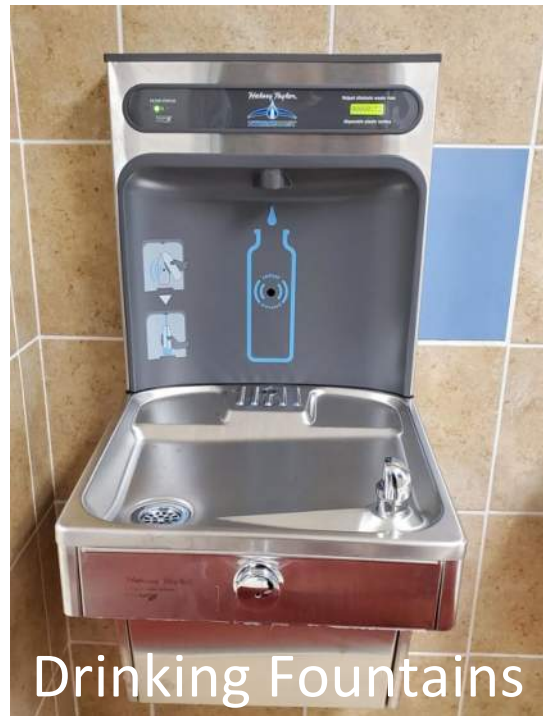
Drinking Fountains

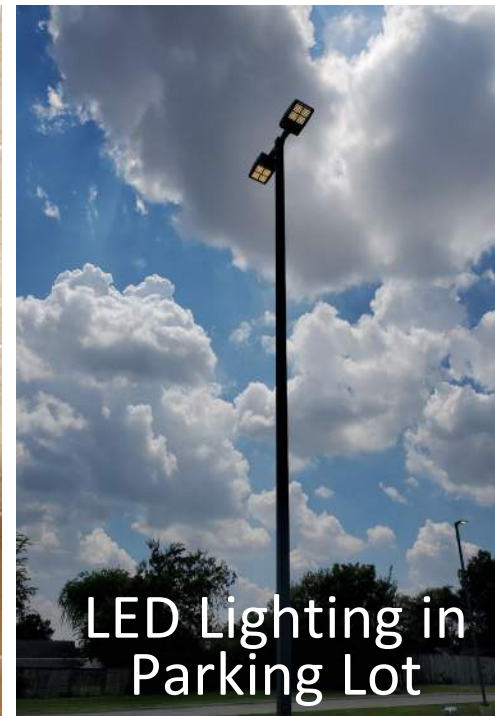
LED Lighting in
Parking Lot

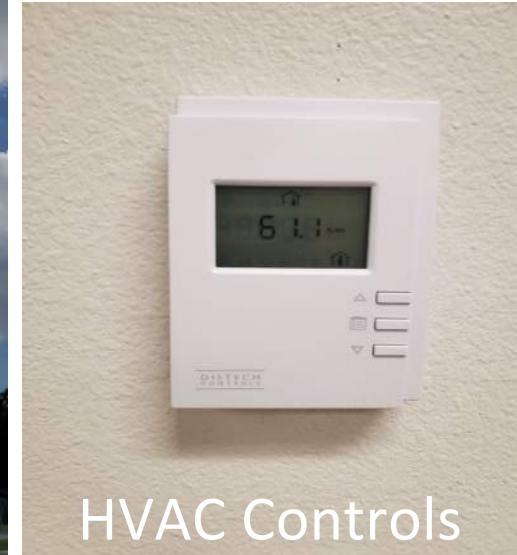
HVAC Controls

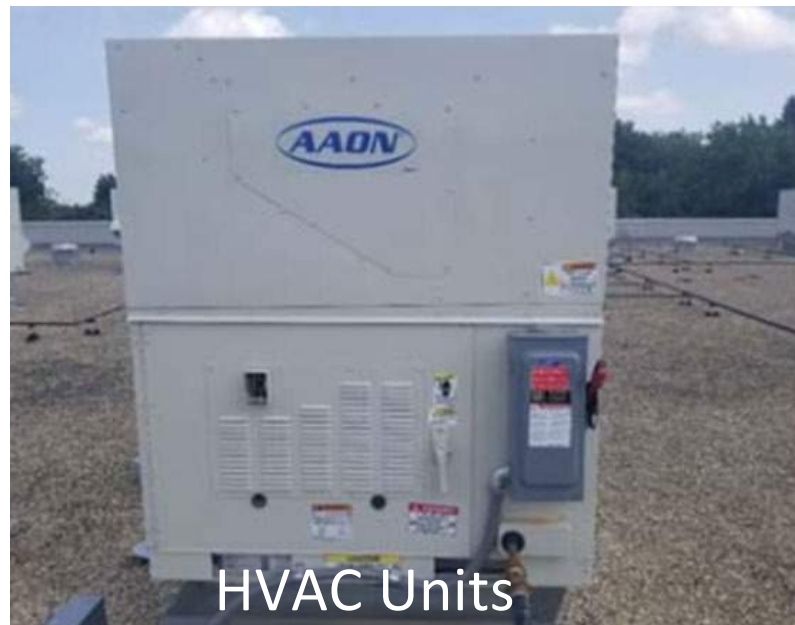
HVAC Units

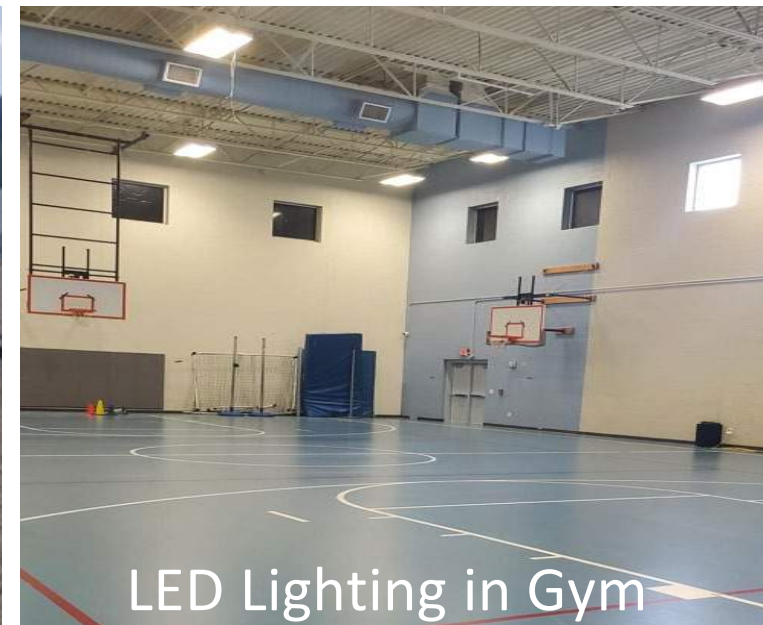
LED Lighting in Gym

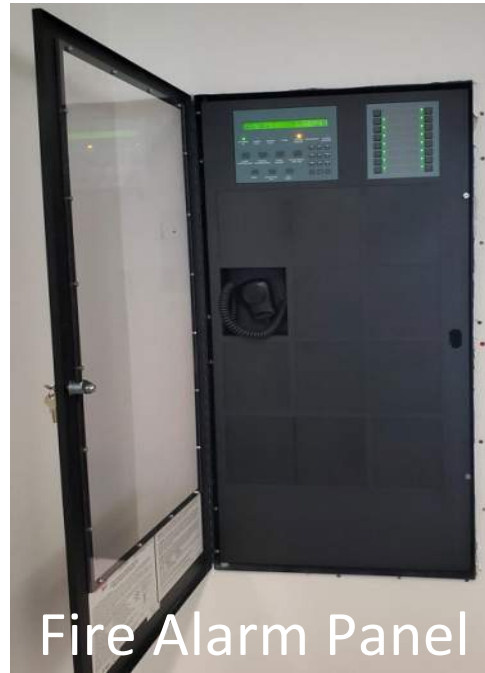
Fire Alarm Panel

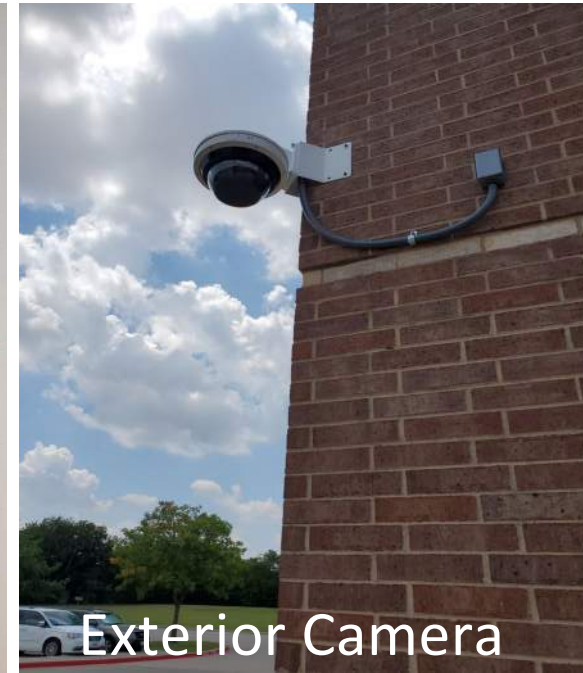
Exterior Camera

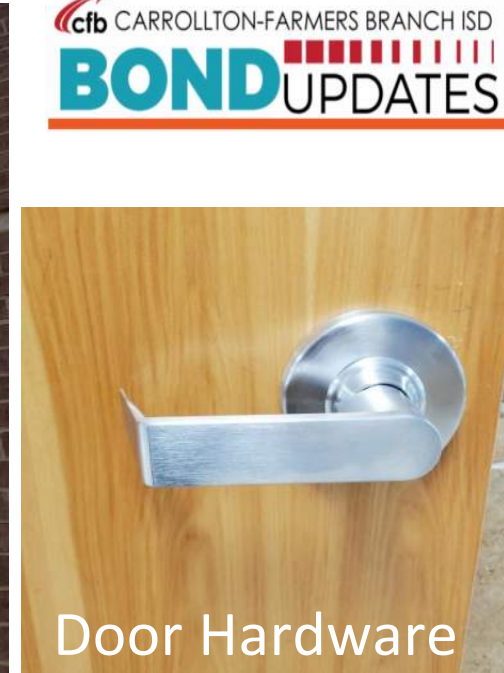
Door Hardware

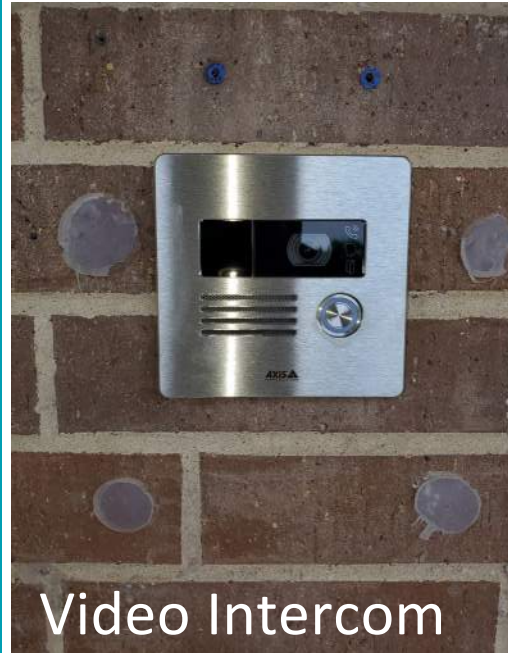
Video Intercom

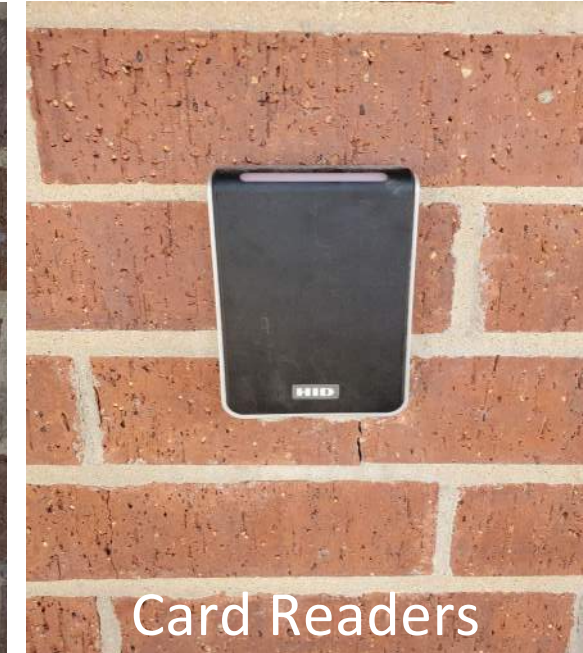
Card Readers

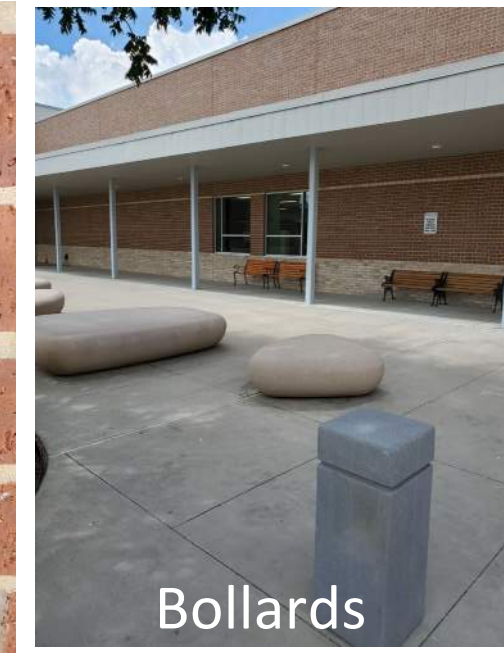
Bollards

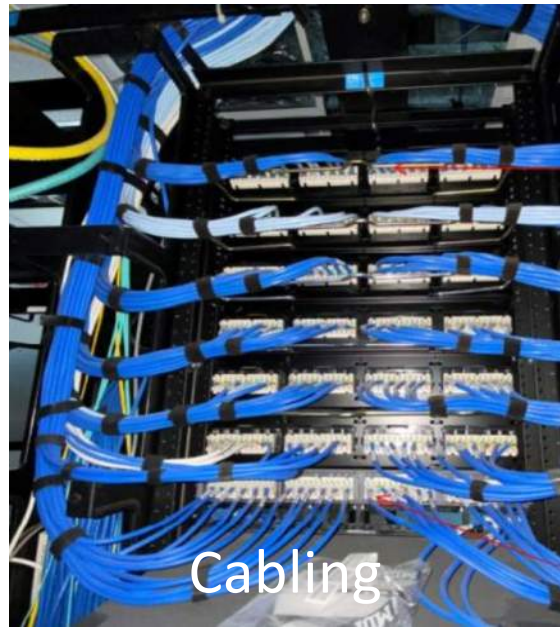
Cabling

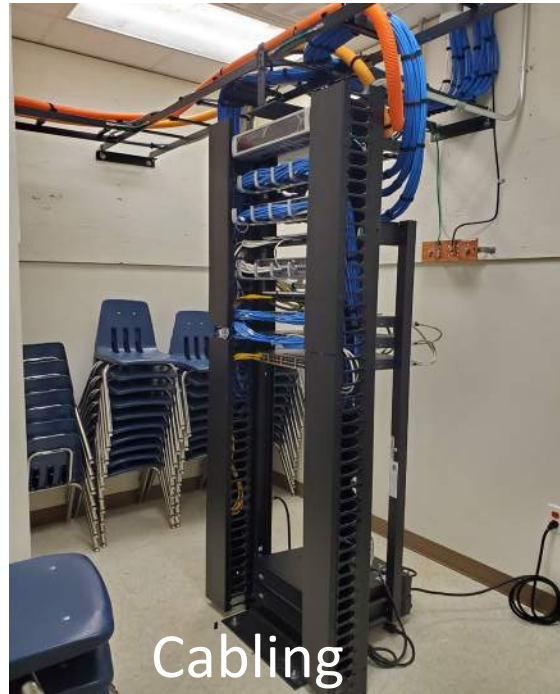
Cabling

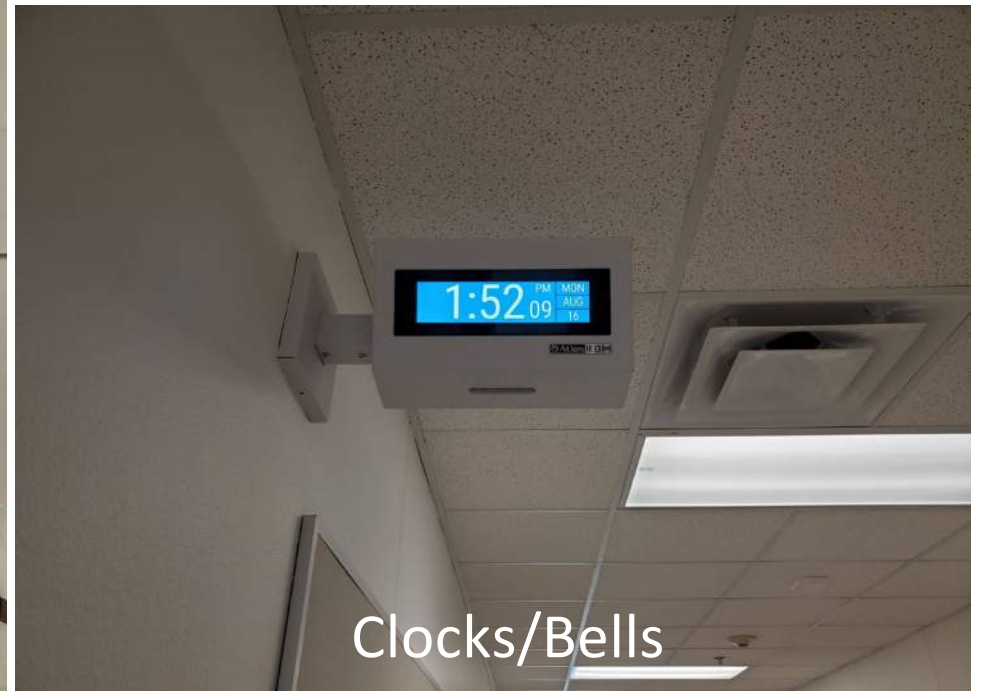
Clocks/Bells
